The remote continuous structural health monitoring of the East 12th Street Bridge

A thesis submitted to the graduate faculty
in partial fulfillment of the requirements for the degree of
MASTER OF SCIENCE

Major: Civil Engineering (Structural Engineering)

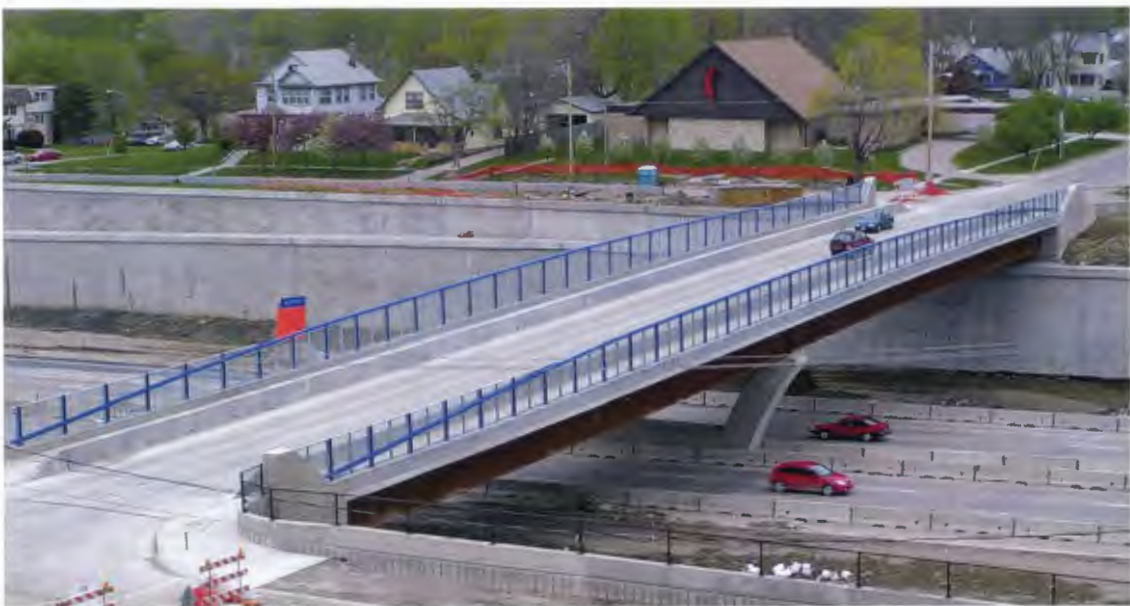
Figure 1.1. East 12th Street Bridge over I-235 in Des Moines, IA.

The E. 12th St. Bridge, constructed using HPS girders, shown in Fig. 1.1, replaced a concrete box girder bridge. The replacement is part of a renovation of the I-235 corridor through Des Moines and the surrounding metro area. The two-span bridge runs nearly North and South. Providing one lane of traffic in each direction, the bridge connects the state capital area on the South to a residential area including East High School on the North.

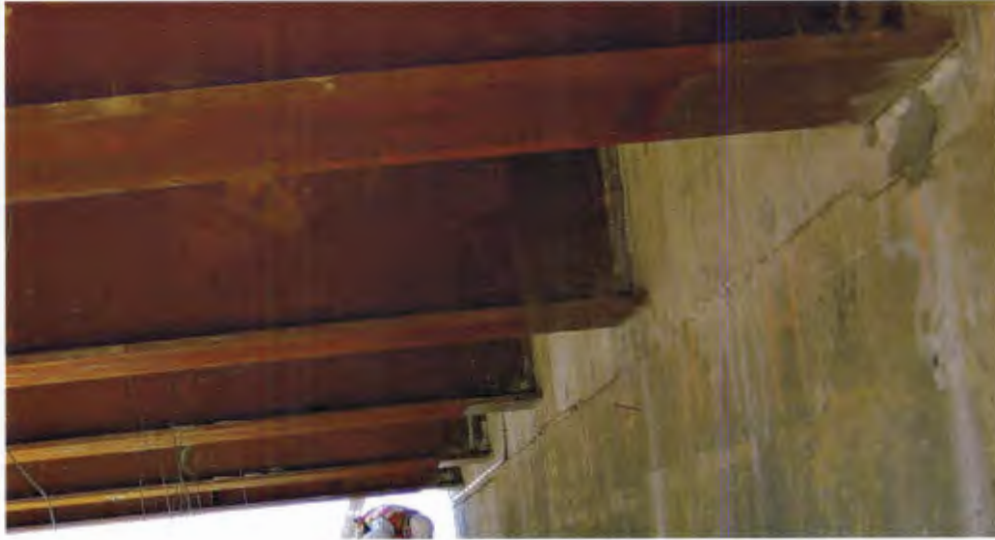
Figure 3.2. Photograph of typical girders and the North integral abutment.

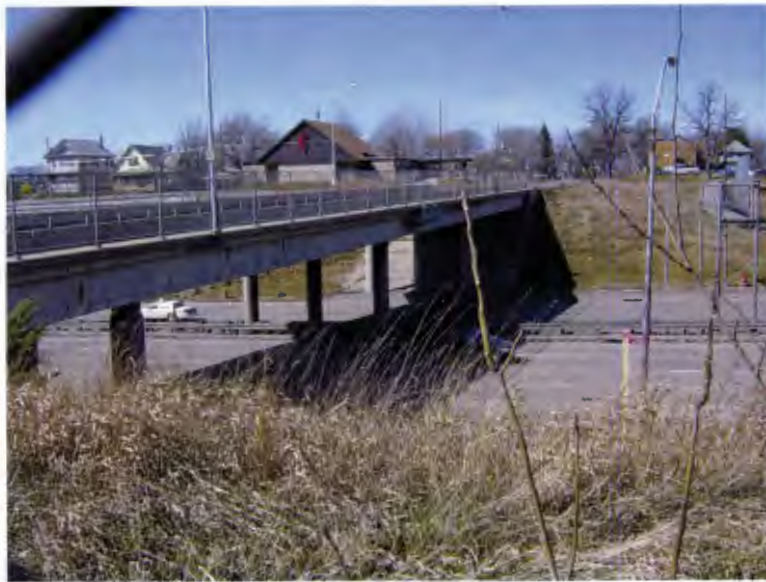
Figure 3.7. Photograph of original E. 12th St. Bridge.

Before construction of the new bridge could begin, the existing concrete box-girder bridge, shown in Fig. 3.7, had to be removed. Demolition began with the removal of the guardrails, light poles, and other items that could be removed without closure of I-235. On the night of Saturday, May 3rd, 2003, I-235 was closed from East 6th St. to East 15th St. to allow the majority of the demolition to take place. Most of the demolition was completed in a conventional manner using track hoes with vibrating hammers that punched holes in the bridge deck. These holes enabled track hoes with buckets to tear apart the bridge with supplemental aide from the vibrating hammer equipped track hoes (see Fig. 3.8). On the night of May 3rd, I-235 was closed to traffic at approximately 12 a.m. Saturday night and reopened to traffic 30 hours later prior to Monday morning rush hour traffic.

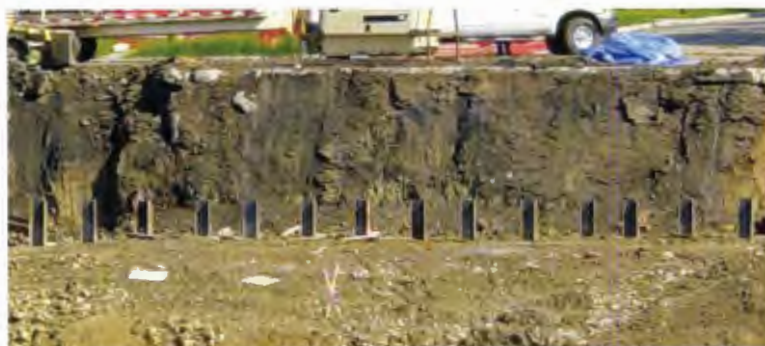
Figure 3.9. Photograph of piles at South abutment before abutment concrete was placed.

After the box girder bridge had been removed, work began by constructing new bridge abutments. As the replacement bridge has integral abutments, work started by driving H-Piles. The North abutment consists of a row of 15-HP10x42 piles with a single HP10x42 pile behind each outer pile in the row, for a total of 17 piles. The South abutment was constructed with a row of 14-HP10x42 piles with a single HP10x42 pile behind the outer pile on the West side of the abutment and 2-HP10x42 piles behind the outer pile on the East side of the abutment, for a total of 17 piles. The piles were driven to a depth where they reached the design bearing value (73 Kips). Exposed piles can be seen in Fig. 3.9 following installation. Following the piles being driven, the top of piles were encased in concrete to form the complete abutment. Figure 3.10 shows an abutment under construction.

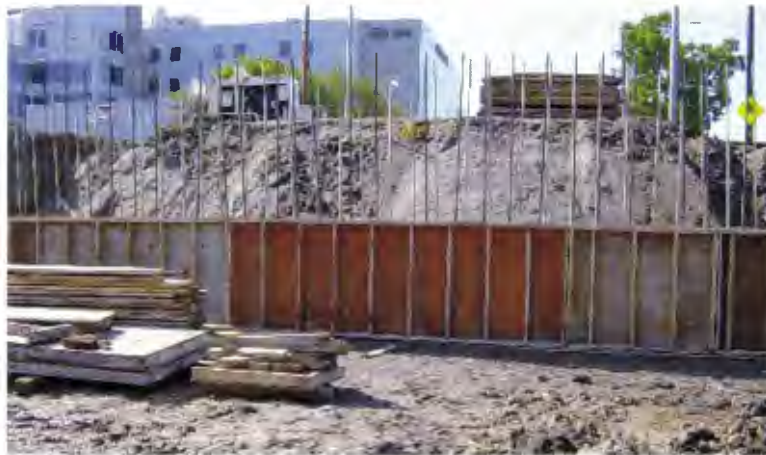
a. Front view of abutment.

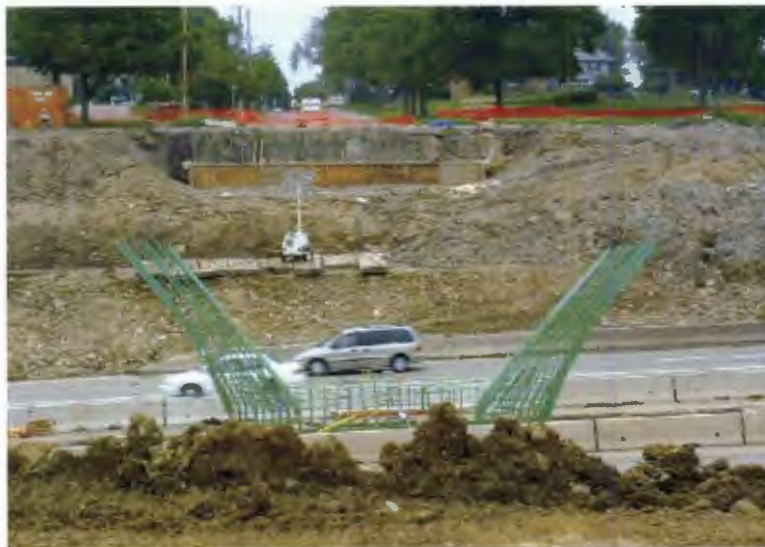
Figure 3.11. Photograph of reinforcing steel for the center pier.

As work was progressing with the abutments, construction of the center pier was also initiated. The original bridge pier foundation was removed and a new foundation was constructed at approximately the same location. Vertical steel reinforcing bars were extended past the top of the foundation to tie the foundation and pier stem together. The reinforcing bars for the pier columns were then tied to the exposed bars, as seen in Fig. 3.11.

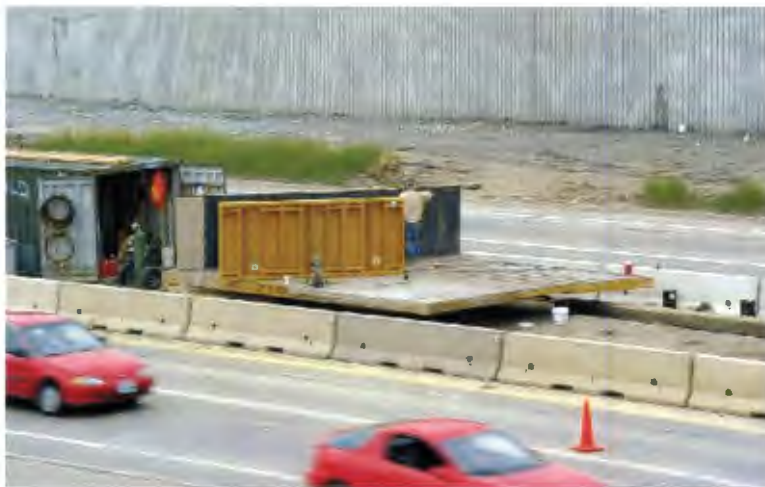
Figure 3.13. Photograph of formwork for the center pier during assembly.

Due to the unique geometry of the V-Pier shown in Fig. 3.12, flat plate girder forms were used to form the North and South sides of the pier (the sides facing the abutments). Adjustable metal forms, with the ability to form radii, were used to form the curved sides of the columns. Three sides of the formwork were assembled on the ground. Specifically, one flat plate girder form was laid horizontal and the radii formwork, were set vertically upon it as seen in Fig. 3.13. This partially complete formwork was then lifted into place with the last flat plate girder form then set into position, thus completing the formwork for the pier stem and columns. The fully assembled pier formwork can be seen in Fig. 3.14.

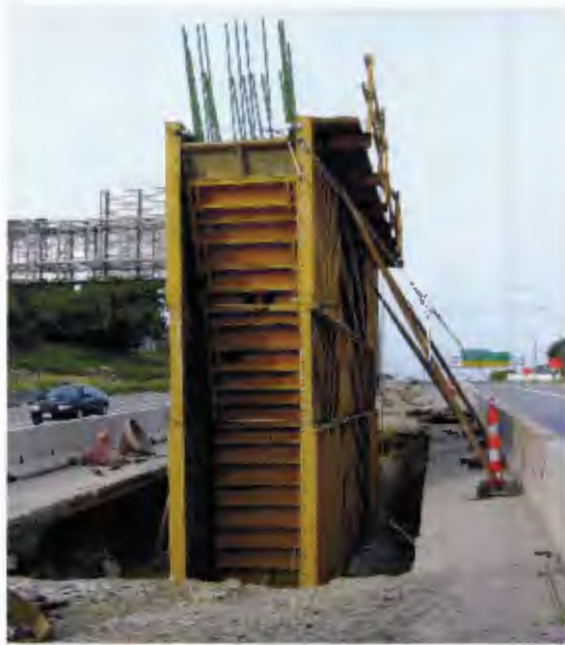
Figure 3.14. Photograph of center pier formwork after assembly and placement.

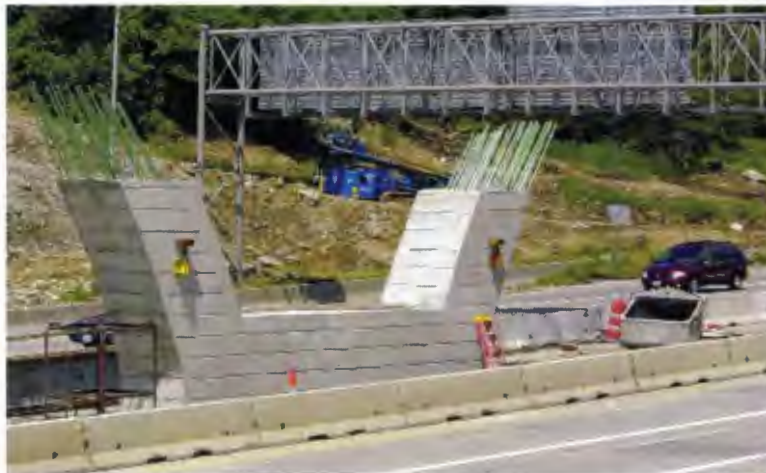
Figure 3.15. Photograph of center pier after formwork was stripped and before reinforcing steel and formwork for the pier cap were constructed.

As with the demolition of the existing bridge, the placement of the concrete for the pier stem and columns could not take occur during the day. Placement of the concrete required multiple lanes of I-235 traffic be shut down because a crane was used to lift the concrete into place and a large number of concrete trucks were needed. Together, these necessitated nighttime placement of the concrete. The completed pier stem and columns are shown in Fig. 3.15.

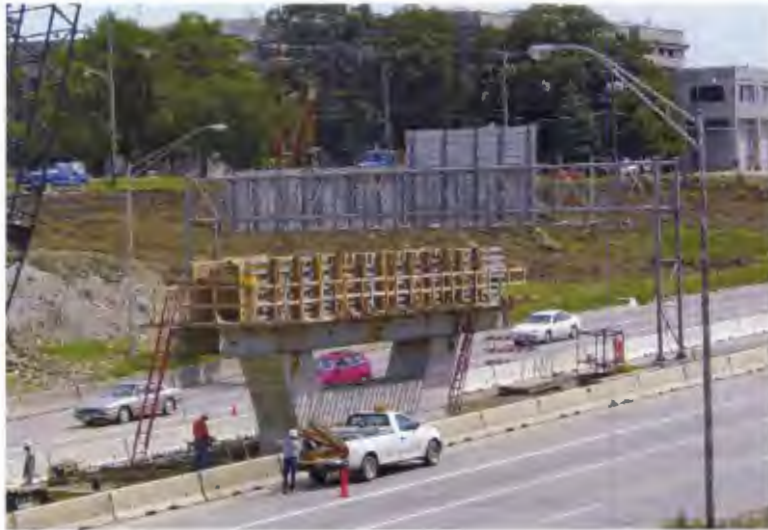
Figure 3.16. Photograph of formwork for the center pier cap being constructed.

Once the pier stem and columns had gained sufficient strength, assembly of the formwork for the pier cap began. The formwork was assembled in-place; this can be seen in Fig. 3.16. Similar to the pier stem and columns, the placement of the concrete for the pier cap also took place during a nighttime shutdown of I-235. The completed pier can be seen in Fig. 3.17.

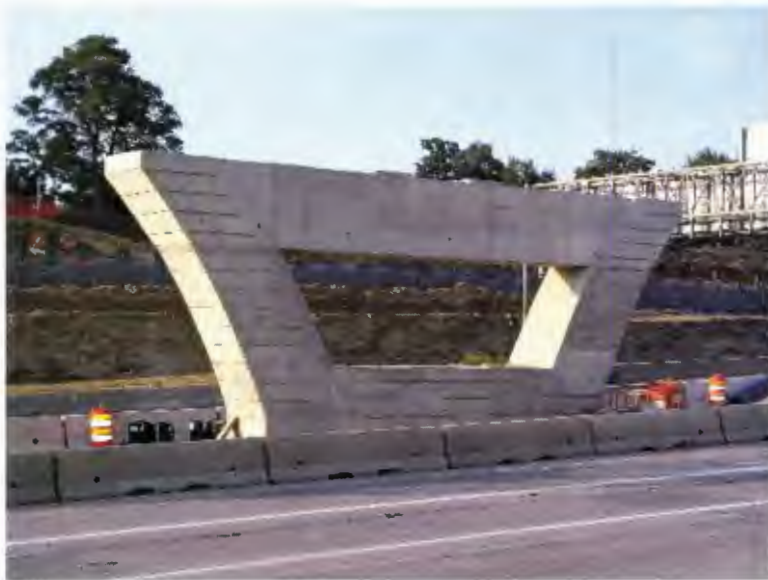
Figure 3.17. Photograph of completed center pier.

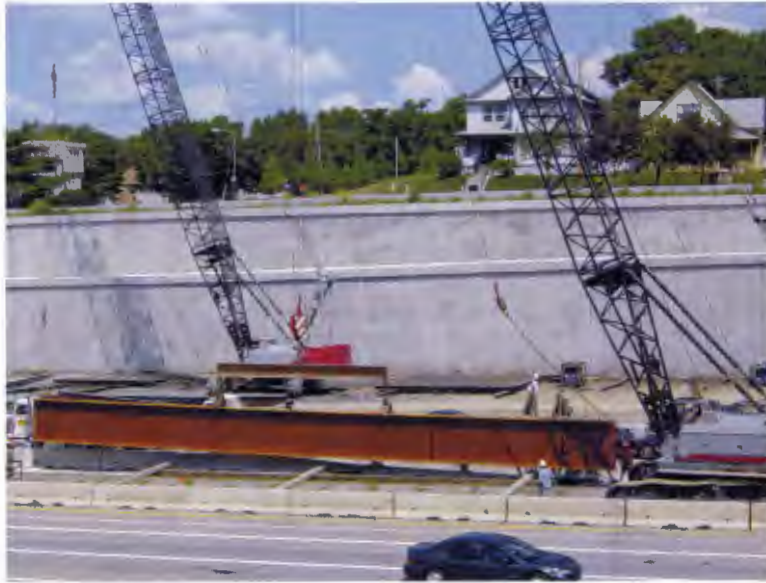
Figure 3.18. Photograph of HPS girder being unloaded following delivery.

The HPS girders used in the bridge were manufactured in Illinois by Industrial Steel Construction, Inc. The girders were shipped to the site, by truck, with 3 to 4 sections of girder delivered at a time (only one section per truck). Delivery took place during non-peak daytime hours when one lane of I-235 could be closed to traffic; this lane was needed for unloading. A delivery can be seen in Fig. 3.18 and several stockpiled girders can be seen in Fig. 3.19. To facilitate construction the “North Region” and “Center Region” sections of girders were stored in the median where they were spliced together before installation. The “South Region” section of the girders were stored on the South side of I-235.

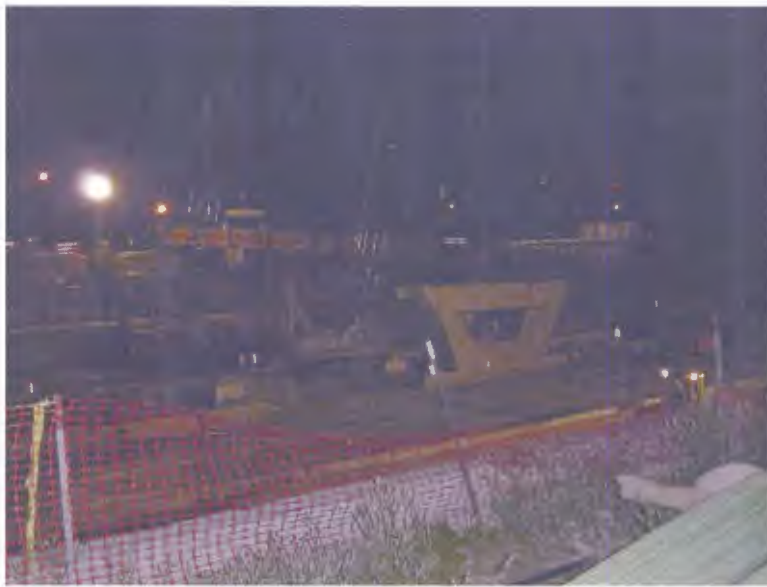
Figure 3.20. Photograph of HPS girder being set during the first of three night time operations.

Erection of the HPS girders was also completed during a nighttime operation. The cranes used to set sections of the girders were temporarily moved directly on the I-235 roadway and the girders were hoisted over the roadway. Setting all the sections and cross-frames of the six girders occurred during three night time operations. During the first night, the “North Region” and “Center Region” of all six girders were set, as shown in Fig. 3. 20. The cross-frames between the set sections of the girders were also installed during the first night.

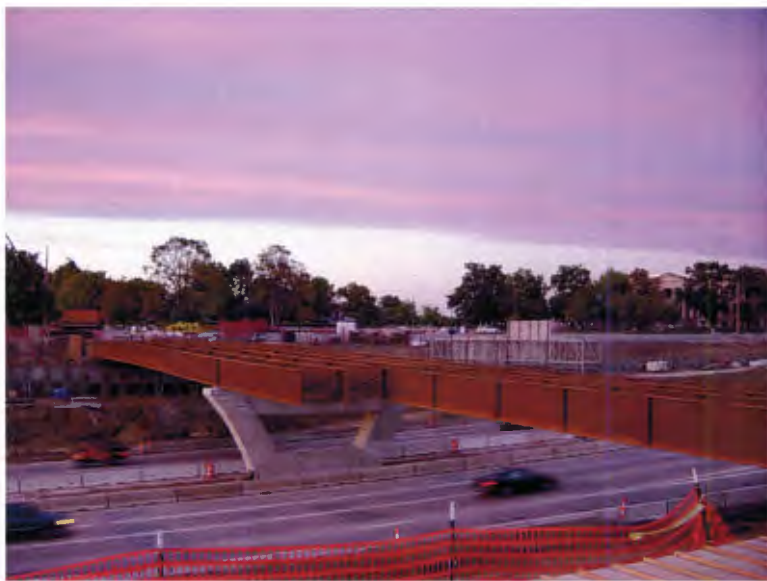
Figure 3.21. Photograph of girders installed after the second night of girder setting operations.

The “South Region” of four of the six girders (G3, G4, G5, and G6) and the corresponding cross-frames were placed during the second night. This is shown in Fig. 3.21. During the third night, the remaining regions of the two girders were installed along with the cross-frames between these sections. The completed framework of girders and cross-frames is shown in Figs. 3.22. A false deck sitting on the bottom flange of the girders was also constructed during the nighttime operations; the false deck can be seen in Fig. 3.23. This false deck served as both a work platform in regions directly over I-235 and prevented construction assemblies or debris from falling on I-235 below.

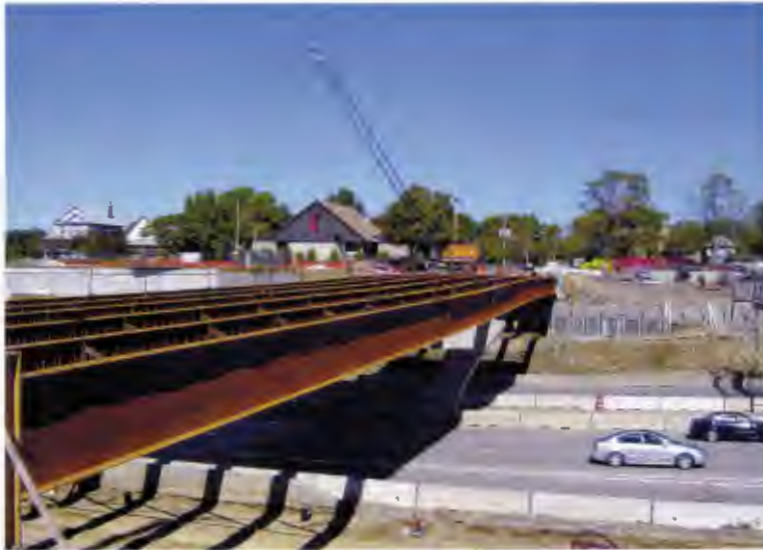
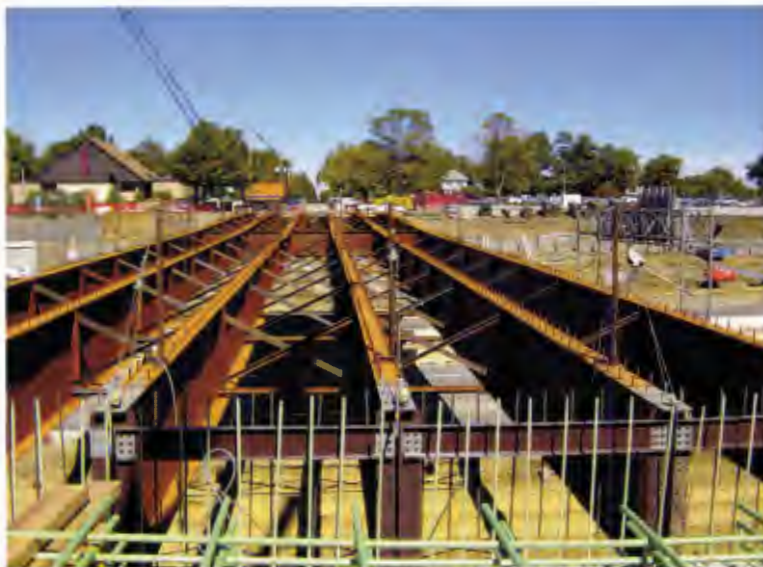
a. Side view of bridge.

b. End view of bridge.

Figure 3.22. Photograph of bridge after all girders have been erected.

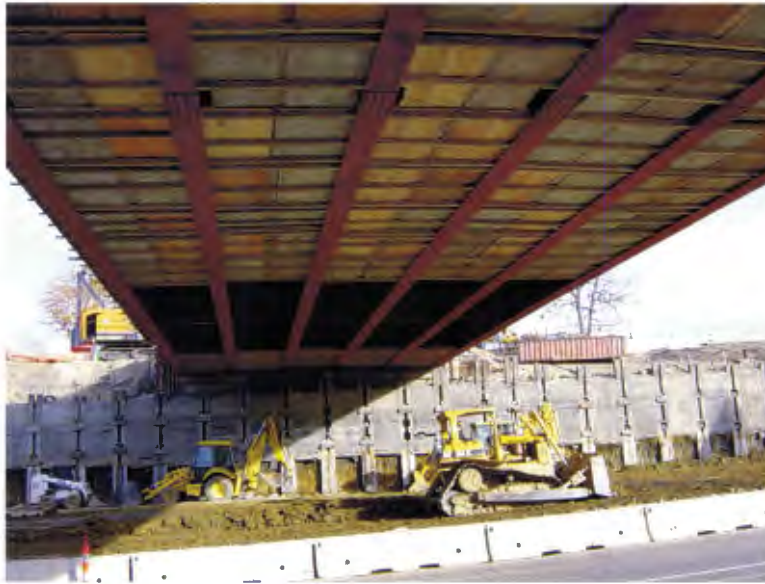
Figure 3.23. Photograph of work platform resting on the bottom flange of the girders over the I-235 roadway.

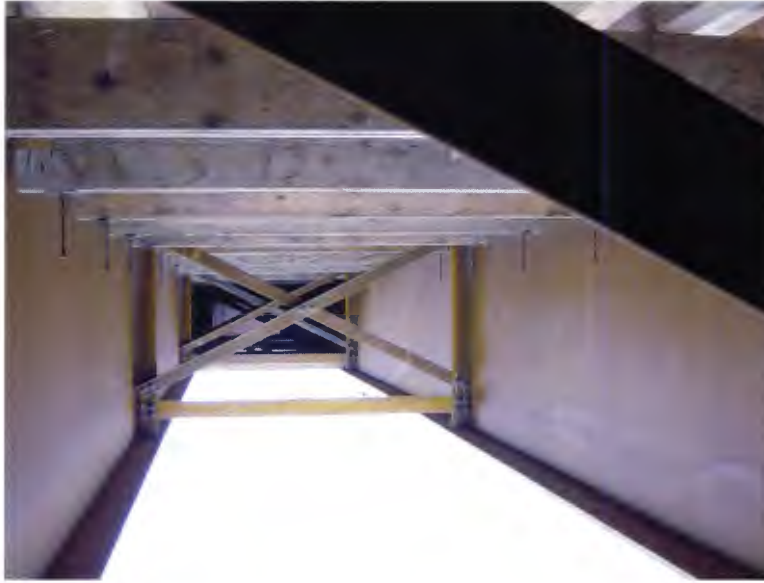
Figure 3.24. Photograph of intermediate cross-frames and deck formwork stringers.

After the formwork and reinforcing bars had been installed for the deck and the integral abutment cap, the first of two sequenced concrete placements took place. In Fig. 3.24 the deck formwork stringers can be seen along with several intermediate cross-frames. The Northern positive moment region and abutment and the Southern positive moment region and abutment were the first placement. After the second placement, consisting of the center negative moment region, had cured to sufficient strength, the pedestrian walkways and the barrier rails were placed. The concrete covered for insulation during curing can be seen in Fig. 3.25. The barrier rails (two on each side, one to guard the edge of the bridge and one to separate pedestrians from traffic) were constructed using a continuous slip forming technique. The completed slip formed barriers can be seen in Fig. 3.26.

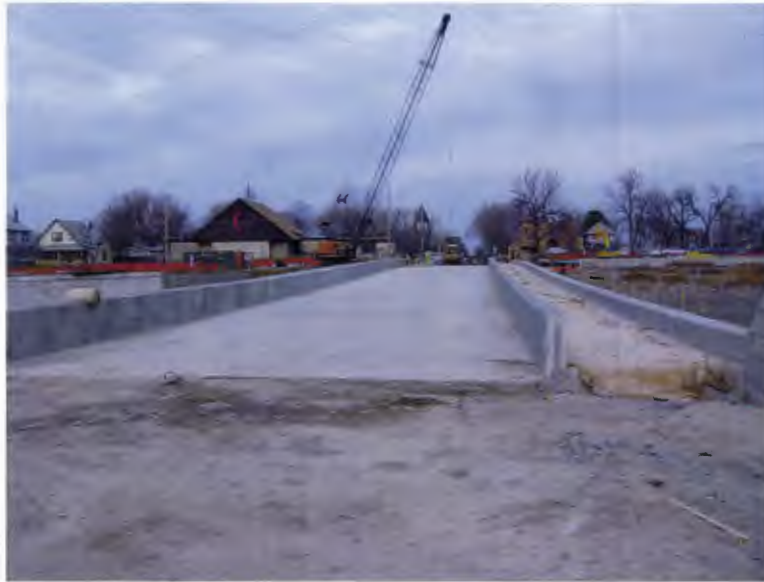
Figure 3.26. Photograph of bridge after slip forming of barriers.

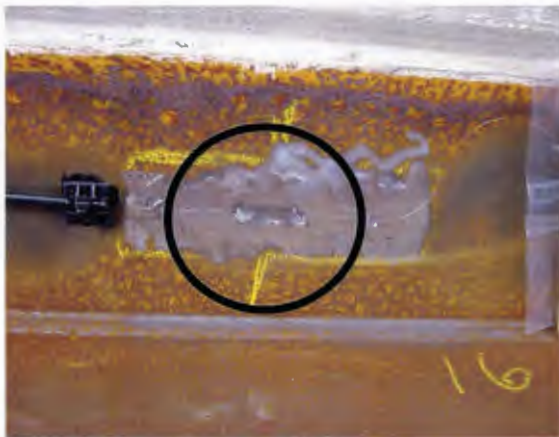
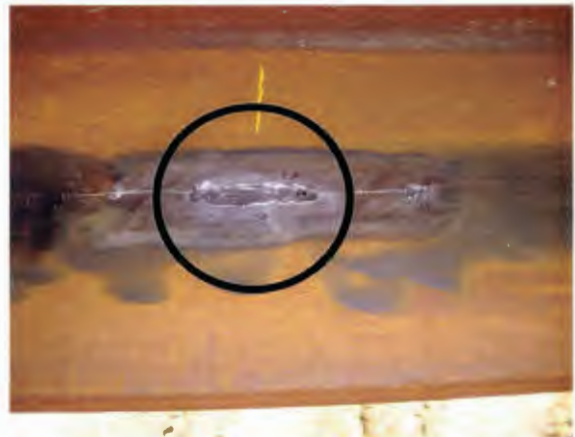
b. Photograph of typical top flange sensor.

c. Photograph of typical bottom flange sensor.

Figure 4.5. Typical top and bottom flange sensors.

Figure 4.5 illustrates the typical placement of the bottom flange (Sensors 3, 4, 14, 17, 19, 20, 22, 24, 25, 26, 28, 31, 32, 33, 35, 37, and 38) and top flange (Sensors 15, 18, 21, 23, 30, 34, 36, and 39) FBG sensors. These sensors are oriented longitudinally and centered between the face of the web and the edge of the flange. In all cases, the top flange sensors were placed on the bottom of the top flange and the bottom flange sensors were placed on the top of the bottom flange.

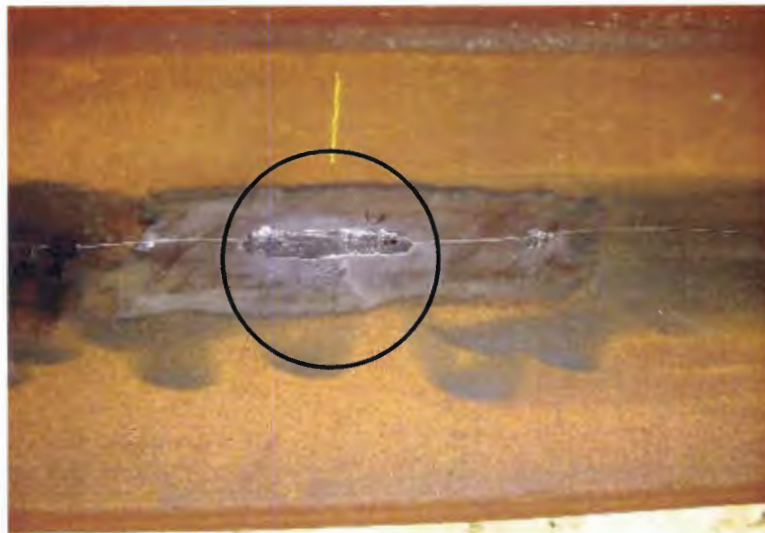
Figure 4.8. Photograph of single bare FBG after installation.

Single bare FBGs were used for 15 of the 40 sensors. These sensors, manufactured by AVENSYS INC/Bragg Photonic Division, were written onto a SMF-28 fiber pigtail with no jacket. The pigtail distances on each side of the sensor were customized for the exact location of the sensor on the East 12th St. Bridge. A bare sensor after installation can be seen in Fig. 4.8.

An array of FBG sensors exists when several single bare FBGs are multiplexed onto a single continuous SMF-28 fiber pigtail. This type of sensor arrangement was custom manufactured by LxSix Photonics, Inc. for this project. Specified distances between the sensors were provided by the project team. Fifteen of the sensors on the East 12th St. Bridge were installed in seven arrays of sensors. An installed single sensor multiplexed into an array looks the same as the single sensor illustrated in Fig. 4.8.

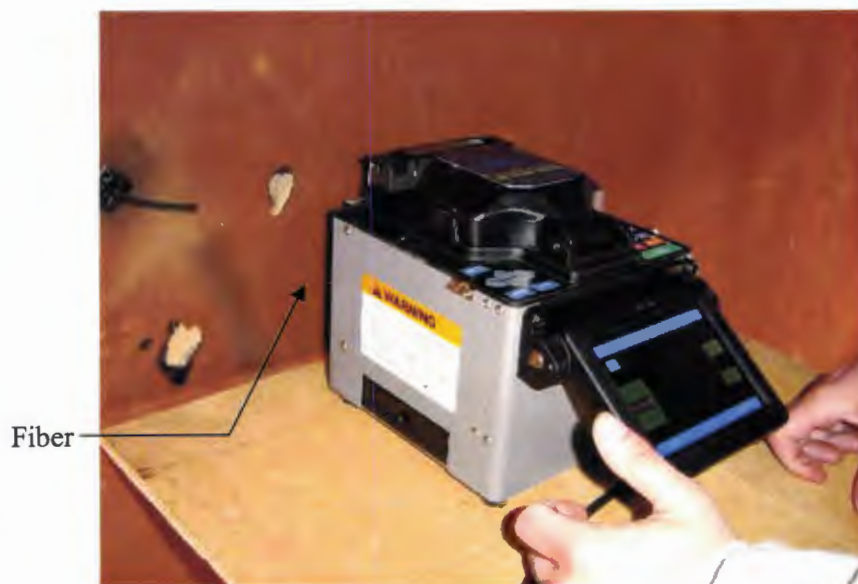
Figure 4.11. Photograph of fusion splicing of two fibers.

Fusion splicing consists of aligning the cores of two separate fibers and then fusing them together. A Fiber Optic Splicing Professional from Huxley Communication, located in Huxley, IA, performed the 37 fusion splices required for the project at a cost of \$35 per splice. Fig. 4.11 shows two fibers being fusion spliced together.

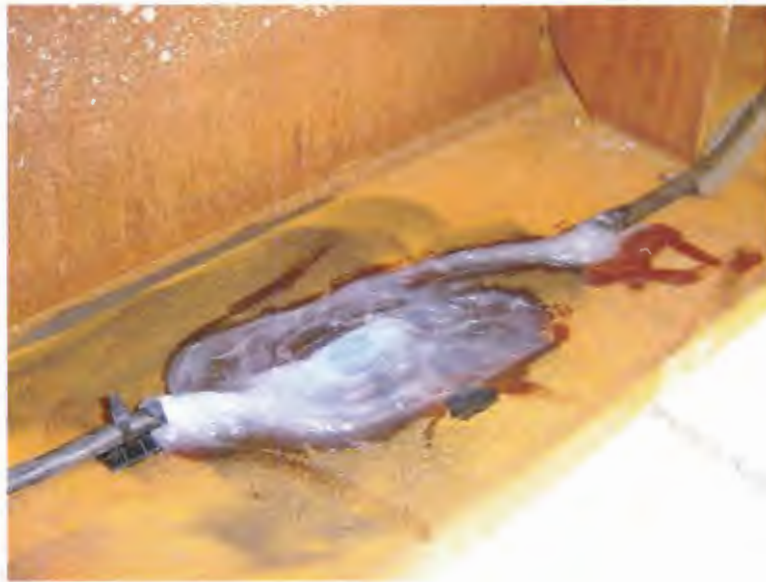
Figure 4.13. Photograph of completed splice after silicone protection has been applied.

(both fusion and mechanical), silicone was used to cover the spliced region. A weatherized fusion splice is shown in Fig. 4.13.

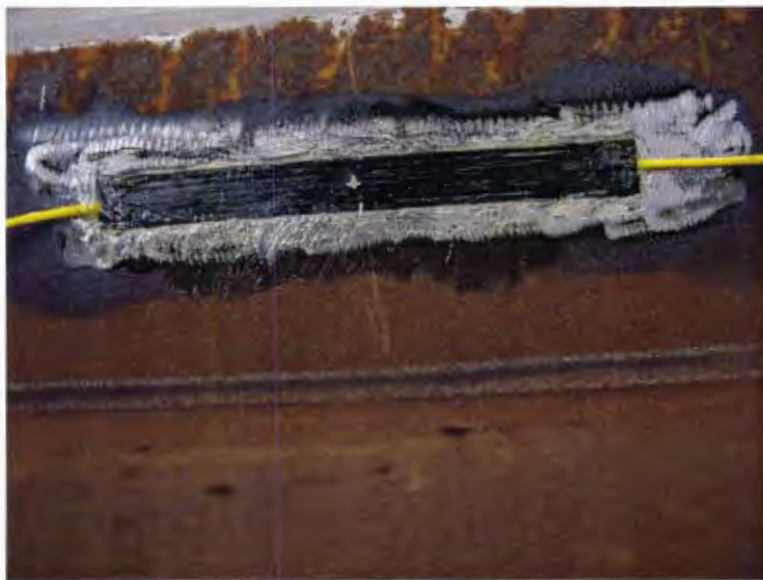
Figure 4.15. Photograph of installed surface mountable sensor.

Surface Mountable Sensor: After the steel surface was prepared as previously discussed, the steel surface was sprayed with Loctite's 7387 Activator. The side of the FRP sensor which was to be in contact with the steel was also sprayed with Loctite's 7387 Activator. After the activator had set, the contact side of the FRP was then coated with Loctite's Structural Adhesive - Rapid Fixture 39. The sensor was then correctly aligned and held in place for approximately 20 sec. until a bond was established. An installed surface mountable sensor is shown in Fig 4.15. After the surface mountable sensors were installed, they were also covered with silicone to protect them from damage.

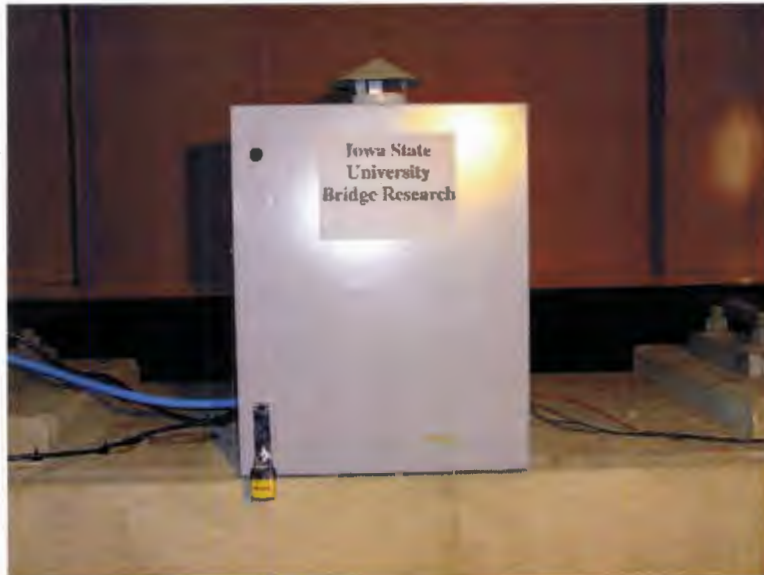
a. Steel cabinet.

The Si425-500 Swept Laser Interrogator (shown in Fig. 4.16) is located at the hub of the DASS, which is centered on top of the bridge pier in the environmentally controlled (through the use of thermostats which control the heaters and fans) steel cabinet pictured in Fig. 4.17. The 35 pound interrogator, which is approximately 17 in. x 17 3/4 in. x 5 1/4 in., has a published operating temperature range of 50°F to 104°F. The Si425-500 operates by emitting a broadband of light from a laser through each of the four data collection channels. Each of the sensors on the fiber optic cable then reflect a single wavelength which the interrogator then registers and stores. The Si425-500 is a wavelength based interrogator which means it can not determine the location of the sensor on the fiber optic cable. Therefore, the reflected wavelength data are stored in ascending order. However, as long as one knows the initial reflected wavelength, from each sensor, one can generally associate the unspecified location data with known locations.

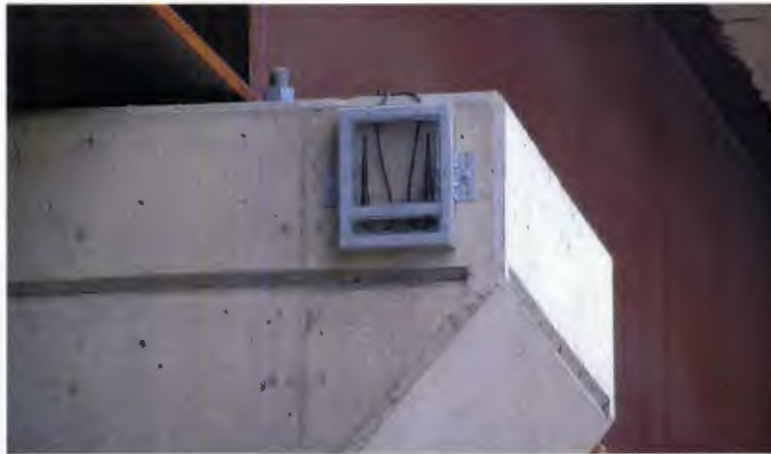
Figure 4.18. Photograph of Data Acquisition Sub-System WAP antennas placed at the edge of bridge pier.

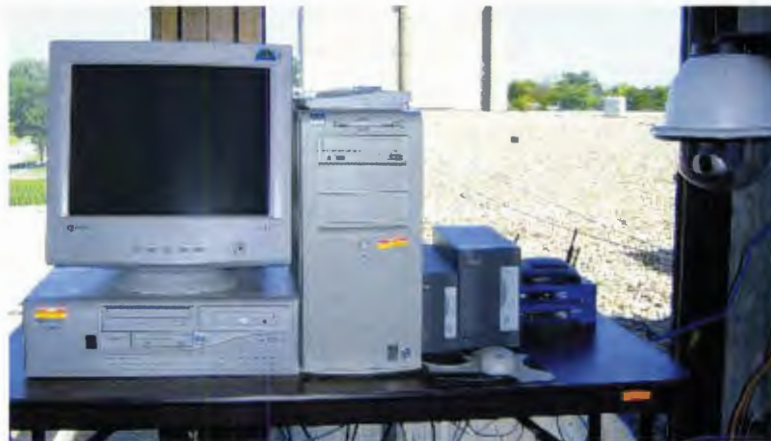
Figure 4.19. Photograph of Gateway Sub-System located in secure facility near bridge.

The GSS, shown in Fig. 4.19 is located in a secure building approximately 450 ft from the bridge pier. Components of the GSS include (manufacturer in parentheses):

- Data Management Equipment (DME)
 - Data Relay Server (DRS)
 - Desktop Computer – 700 MHz Processor, 20.0 GB Hard Drive, 256 MB RAM (Gateway)
 - Data Collection Server (DCS)
 - Desktop Computer – 733 MHz Processor, 14.2 GB Hard Drive, 256 MB RAM (Dell)
- Communication Equipment
 - 2.4 GHz Wireless-802. 11g Access Point (Linksys)
 - 2.4 GHz Wireless-802. 11g Router (Linksys)
 - 678 DSL Modem (Cisco)
- Video Equipment
 - Canon VB-C10/VB-C10R Network Camera

The GSS WAP, DRS, DCS, DSL modem, and the video camera are all connected to one another through the Linksys router by Ethernet cables, which enable all of the GSS components to communicate with one another. All of the components were assigned a static IP address, thus creating a consistent GSS LAN. When data need to be transferred for permanent data storage (discussed subsequently) and client real-time data access, the Cisco 678 DSL Modem is used. This modem has the ability to download at 1.5 MBps and upload at 1.0 MBps.

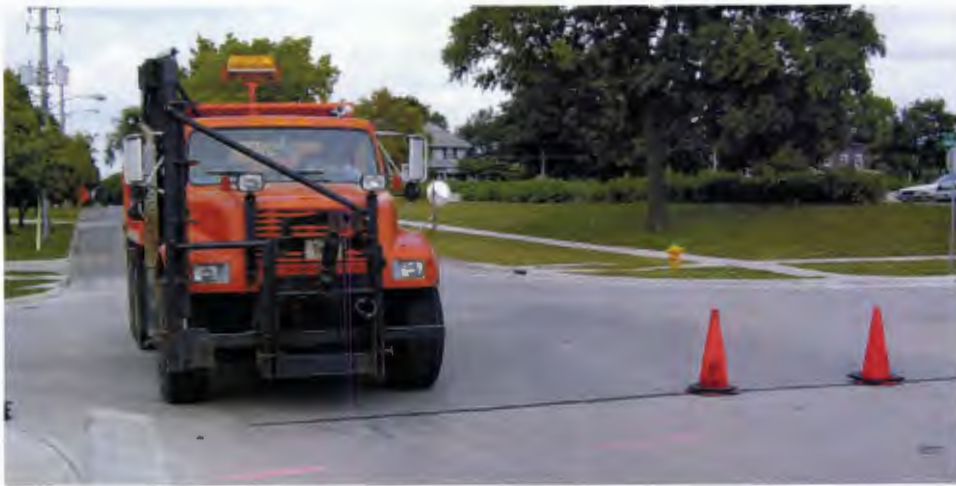
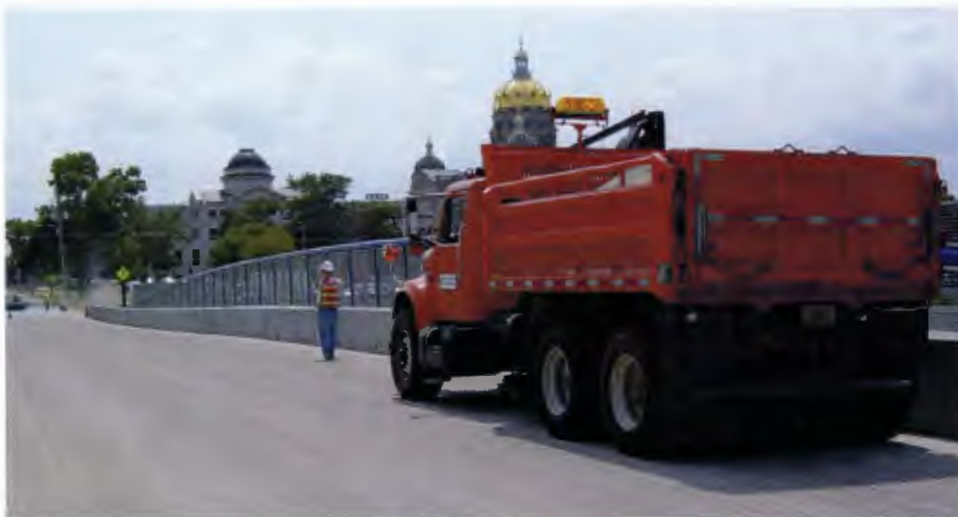
a. Load truck prior to controlled load test

b. Load truck during Run 2 of the controlled load test

Figure 5.3. Photos of the load truck used for the controlled load test.

The controlled load test was performed by collecting strain data while a truck of known weight and configuration was driven across the bridge. The configuration of the load truck used in the load test is shown in Fig. 5.1. The front axle weight of the truck was 15,120 lbs. and the rear axle weight was 31,680 lbs. Table 1 gives a summary of the truck weight. The controlled load test consisted of nine runs, several runs were conducted at each location for repeatability. Runs 1 and 2 were conducted with the center of the west rear wheels 2 ft from the west barrier rail. The truck was centered on the bridge for Runs 3, 4, 7, 8, and 9. Runs 5 and 6 were conducted in a symmetrical fashion to Runs 1 and 2 on the other side of the bridge, with the East rear wheel 2 ft from the east barrier rail. The positions of the truck for the different runs of the load test are shown in Fig. 5.2. Runs 1 through 6 were performed at crawl speeds, Run 7 at 15 mph, Run 8 at 25 mph, and Run 9 was performed at 35 mph. Runs 7 through 9 were conducted to collect data for dynamic observation. All of the runs were conducted with the vehicle traveling from North to South. Photos of the truck before and during the load test are shown in Fig. 5.3.
